PONDEROSA PINES DAM

NDI ID NO. PA-00304
DER ID NO. 64-204

PHASE I INSPECTION REPORT
NATIONAL DAM INSPECTION PROGRAM

Prepared by
Geo-Technical Services, Inc.

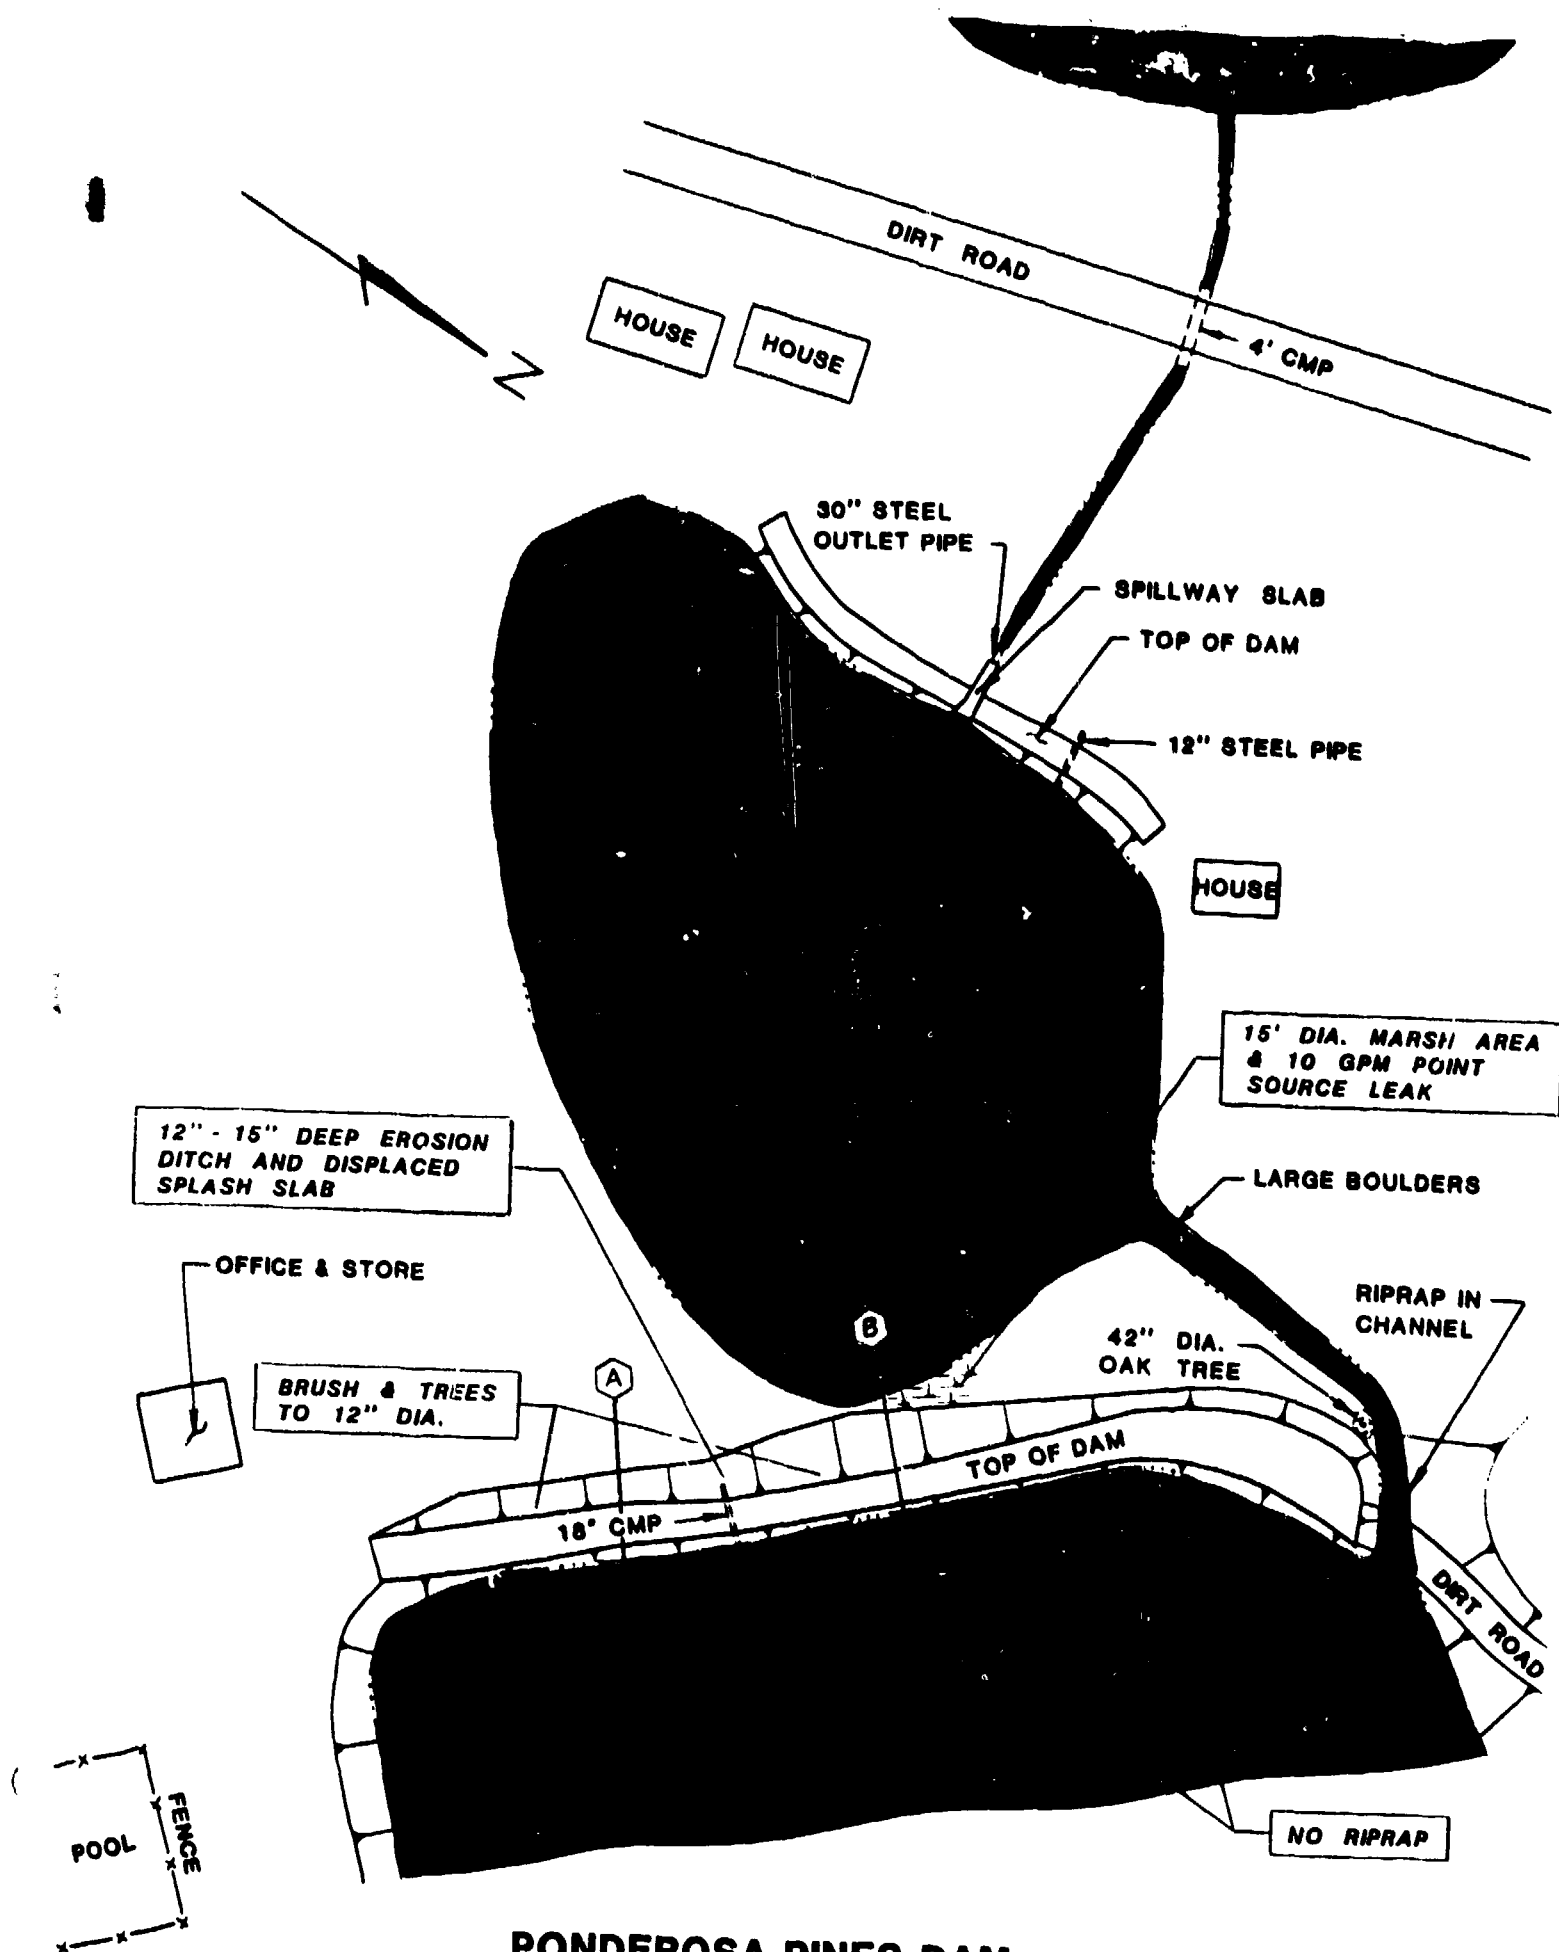
**PONDEROSA PINES DAM
GENERAL PLAN - FIELD INSPECTION NOTES**

a. General: The overall appearance of the dam is poor. Deficiencies observed during the field inspection are illustrated on the General Plan, Exhibit A-1 of Appendix A. Surveyed profile of the dam crest, typical dam sections and details of the appurtenant structures are presented in Exhibits A-2, A-3 and A-4, respectively (see Appendix A). The survey datum for this inspection is based on interpolation of the USGS contour lines (see Exhibit E-1). On the inspection date (June 25, 1981), the pool was at elevation 1405.1, 0.1 foot above the normal pool. Pertinent observed features are shown in photographs, presented in Appendix C.
